## Annual Inspection

East Hertfordshire District Council

Tonwell Recreation Ground (Bengeo PC)

Inspected: 15-September-2025 - 15:01 by James Law (RPII Annual Inspector)

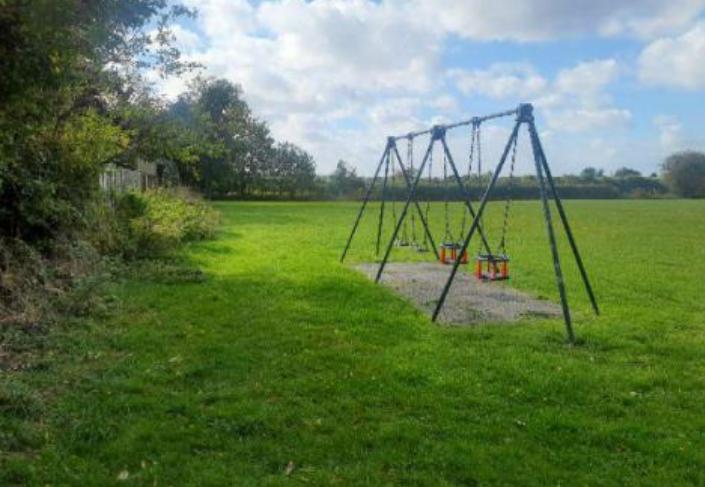
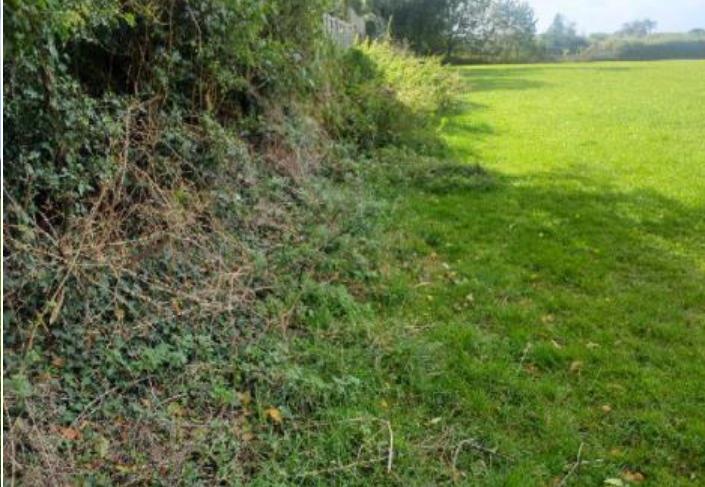
There is weed / vegetation growth within the surface - Remove weed / vegetation growth

**Finding:** There is weed / vegetation growth within the surface

**Action:** Remove weed / vegetation growth

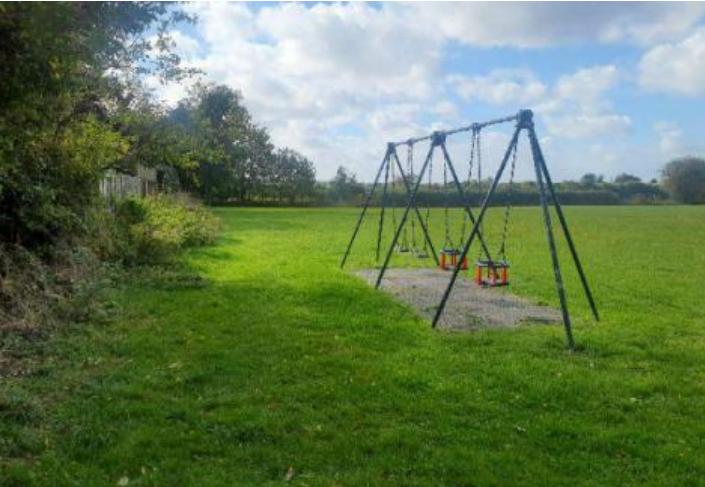
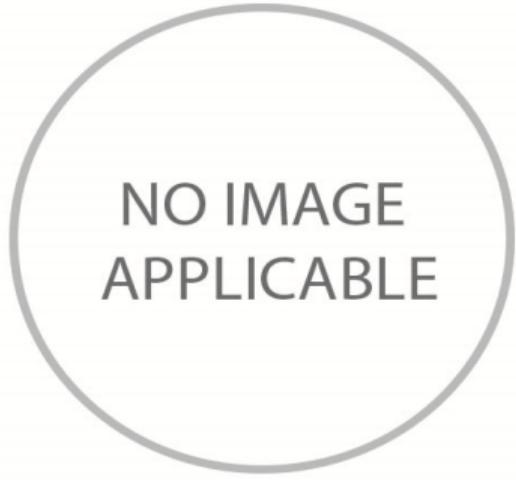
It is recommended that signage, with information including the site address, contact information for maintenance issues and emergency contact details are provided for the facility - Provide in accordance with the recommendations

**Finding:** It is recommended that signage, with information including the site address, contact information for maintenance issues and emergency contact details are provided for the facility

**Action:** Provide in accordance with the recommendations

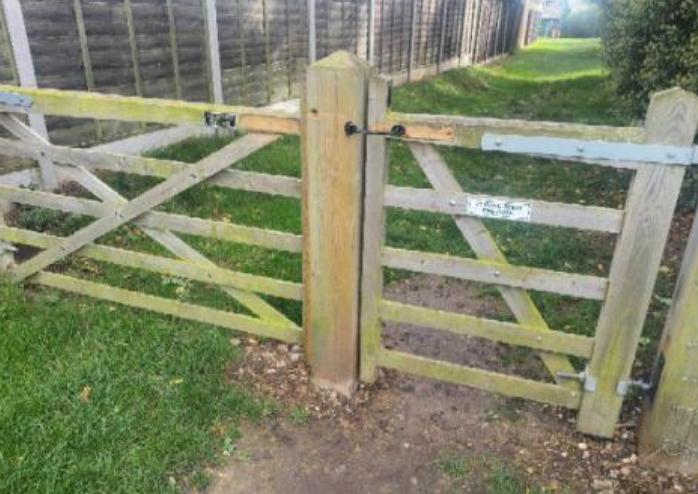
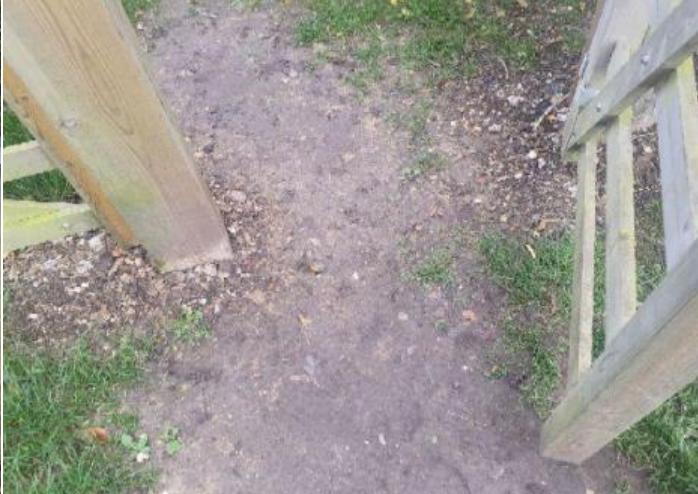
The area around the item has eroded and may become slippery - Reinstate eroded area

<b>Finding:</b> The area around the item has eroded and may become slippery	<b>Action:</b> Reinstate eroded area

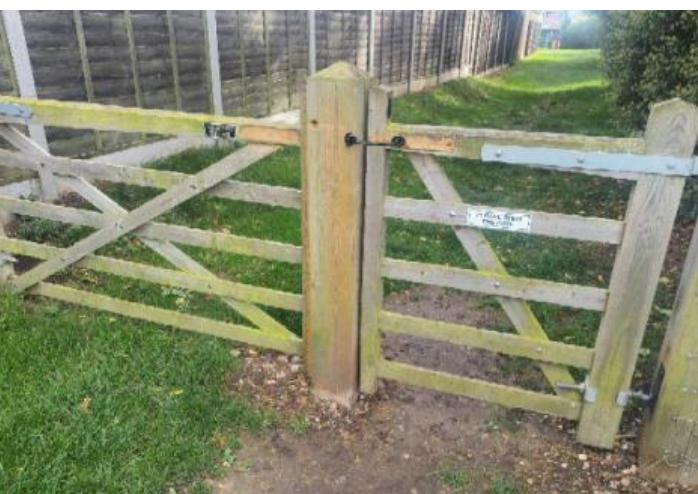
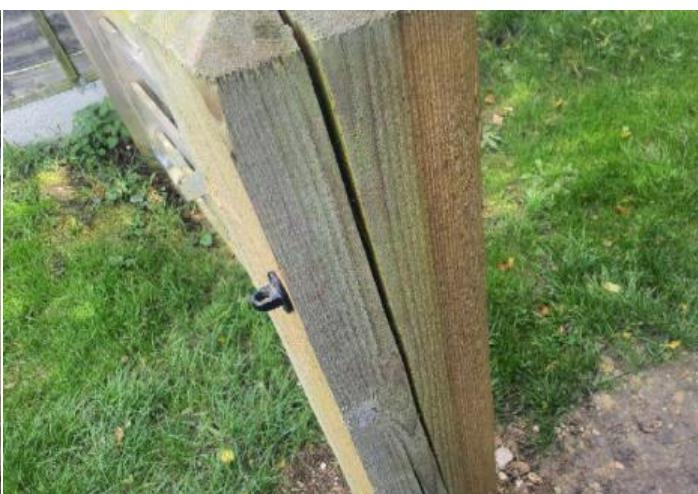
The timber has a number of splits/shakes or air cracks and this may affect the stability or allow water ingress which will accelerate the rotting process. Timber splits may also create rough / splintering edges. - Monitor, sand down any rough edges and ensure the splits do not cross through fixing points of the structure and/or cause any instability

<b>Finding:</b> The timber has a number of splits/shakes or air cracks and this may affect the stability or allow water ingress the splits do not cross through fixing points of the structure which will accelerate the rotting process. Timber splits may also create rough / splintering edges.	<b>Action:</b> Monitor, sand down any rough edges and ensure the splits do not cross through fixing points of the structure and/or cause any instability

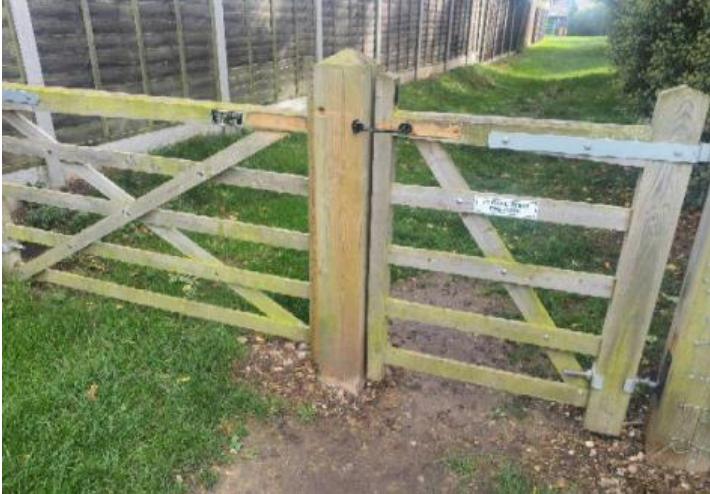
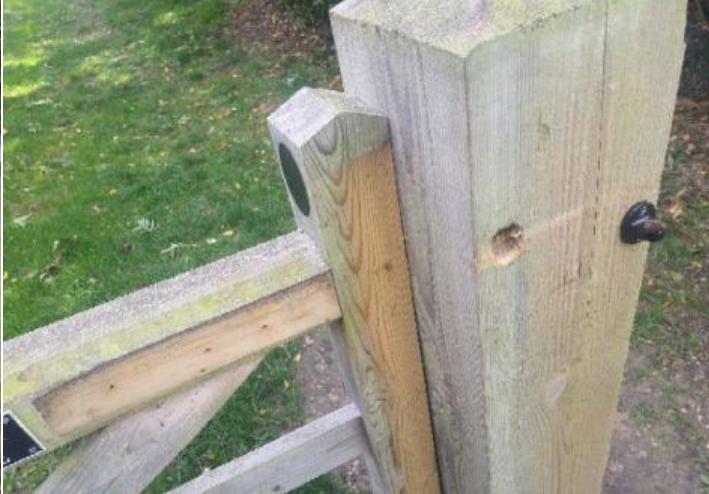
There are openings that are less than 12mm that could trap or crush fingers - Provide a 12mm gap throughout full range of motion at both sides of gate

<b>Finding:</b> There are openings that are less than 12mm that could trap or crush fingers		<b>Action:</b> Provide a 12mm gap throughout full range of motion at both sides of gate

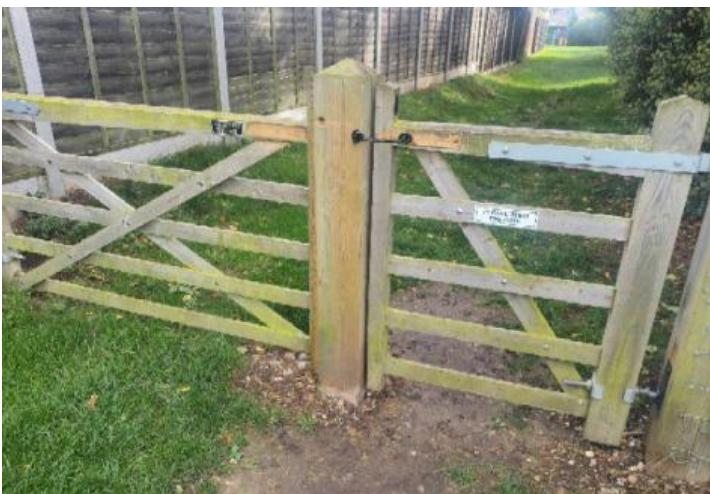
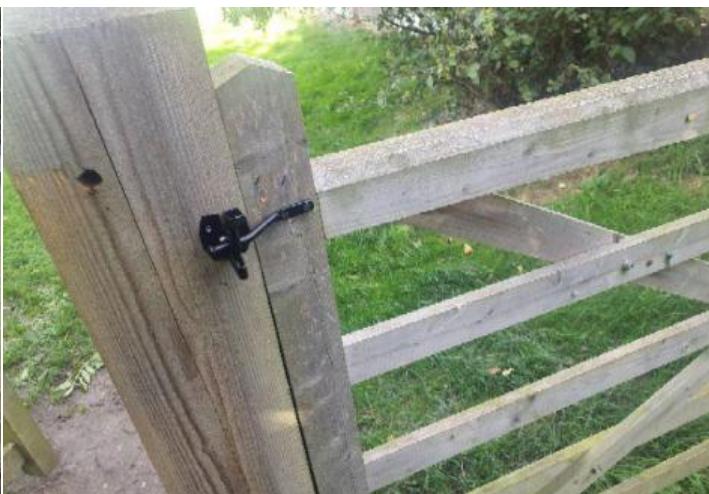
There is no padlock on the maintenance gate - Provide a padlock to secure the gate

<b>Finding:</b> There is no padlock on the maintenance gate		<b>Action:</b> Provide a padlock to secure the gate

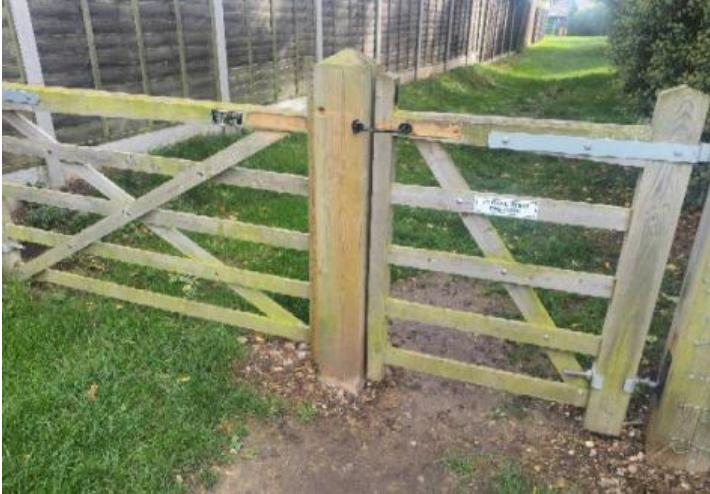
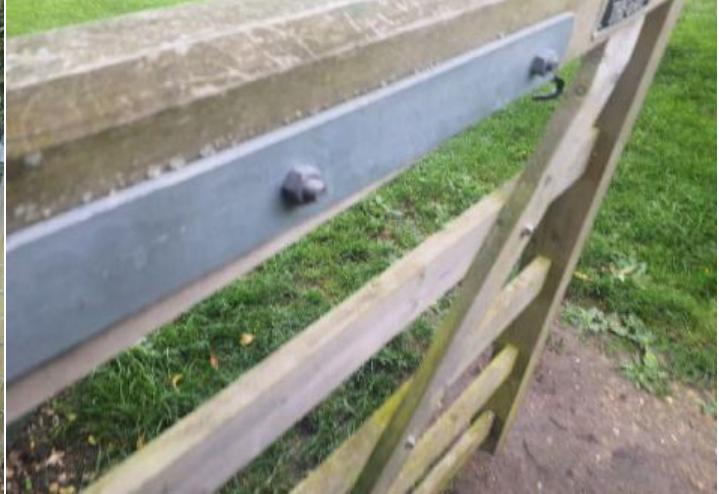
There are projecting bolt thread(s) present - Remove excess thread length and deburr or provide cap

<b>Finding:</b> There are projecting bolt thread(s) present	<b>Action:</b> Remove excess thread length and deburr or provide cap

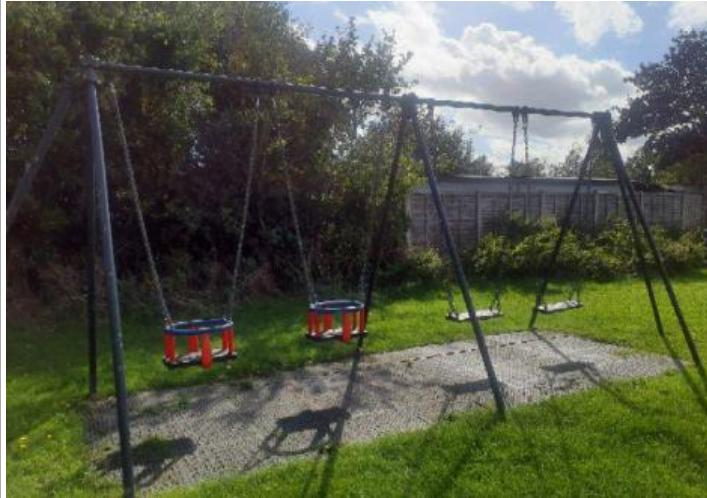
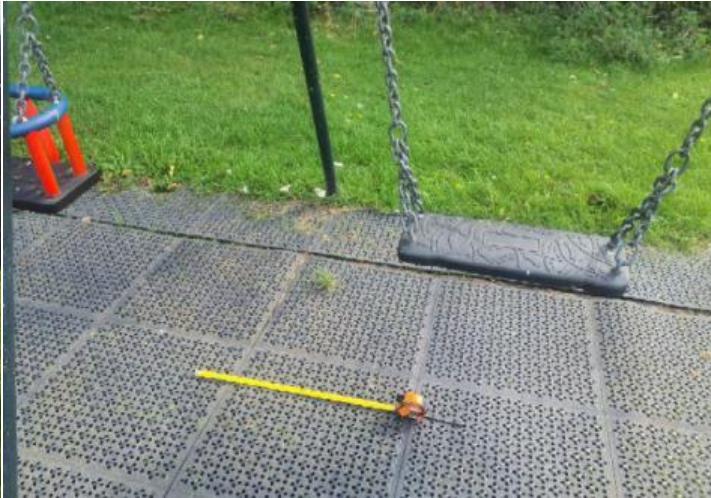
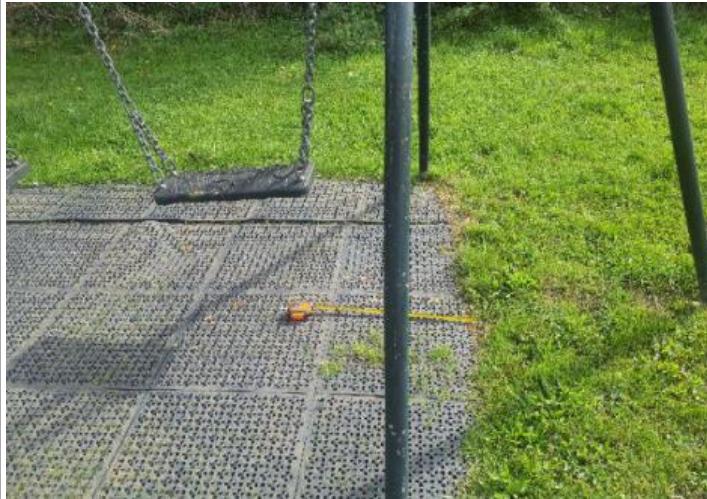
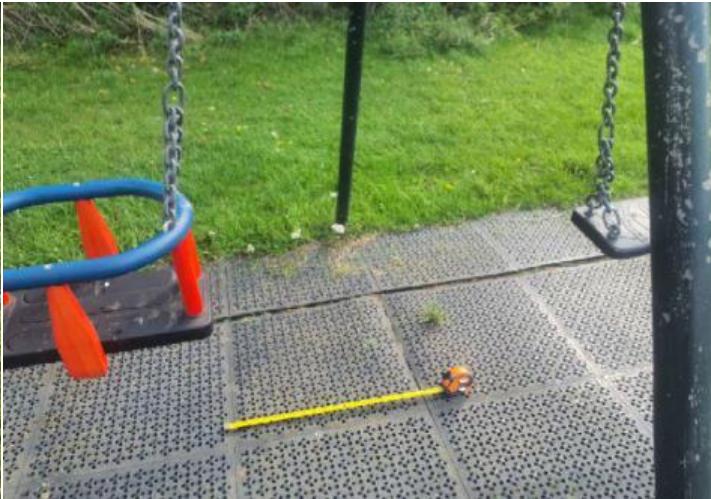
**Finding:** The seat/s is / are too close to the frame as defined in BS EN 1176 Part 2

**Action:** Monitor - No action given the risk assessment

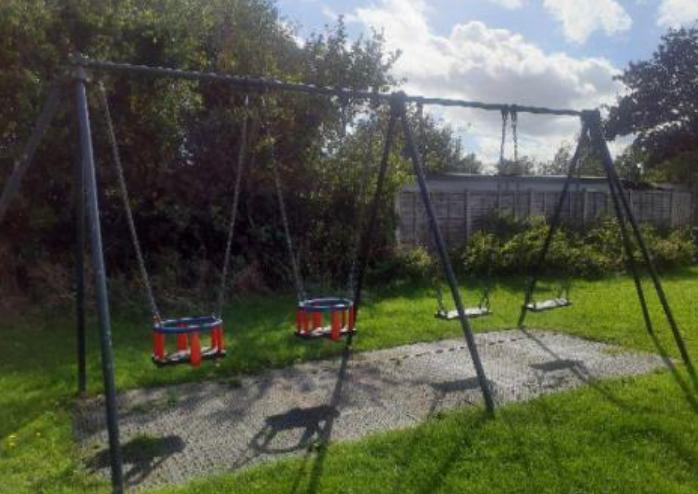
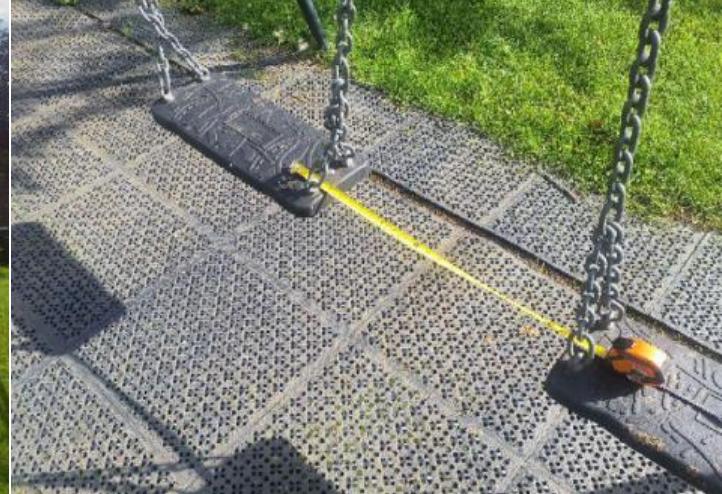
<b>Finding:</b> The seats are too close to each other as defined in BS EN 1176 Part 2; this is a low risk failure and no remedial action is required	
<b>Action:</b> Monitor - No action given the risk assessment

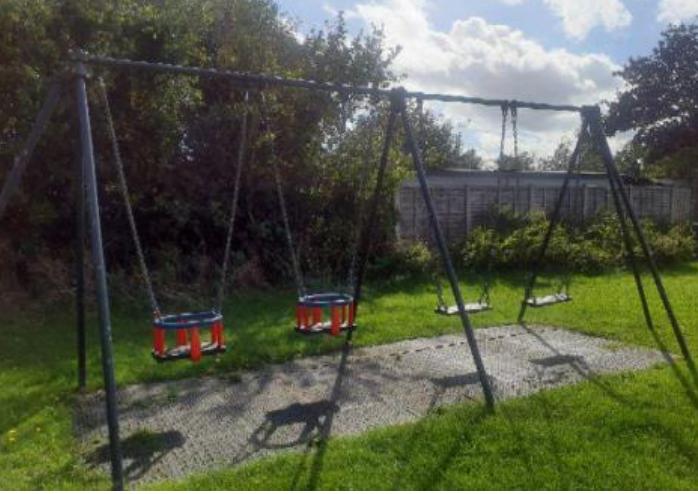
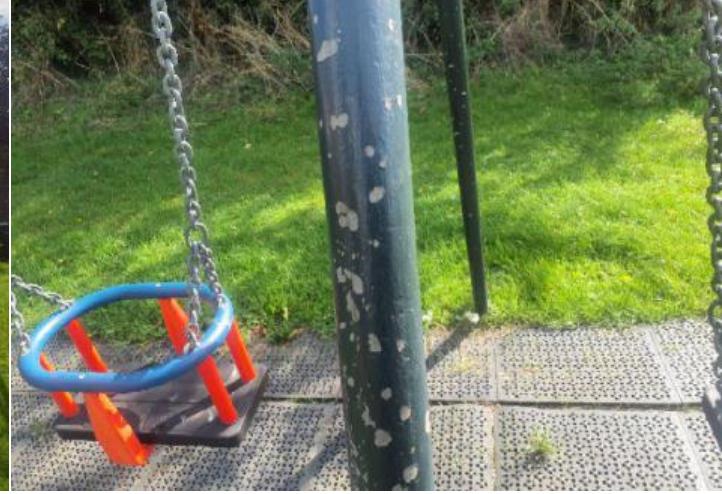
<b>Finding:</b> The paint is flaking off the metalwork	<b>Action:</b> Rub down and re-paint

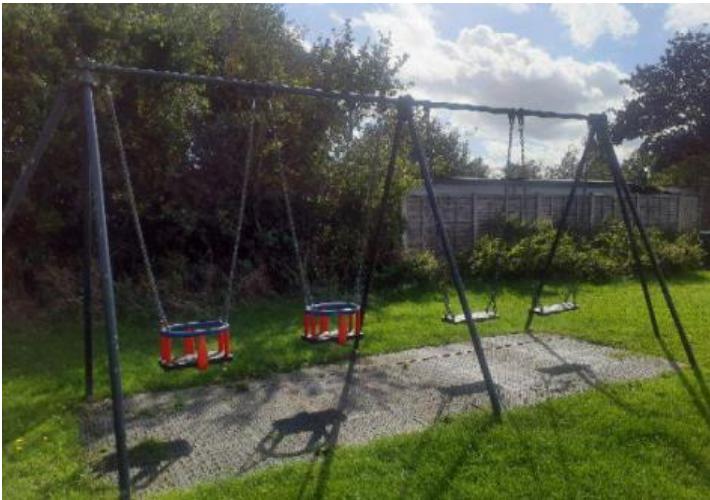
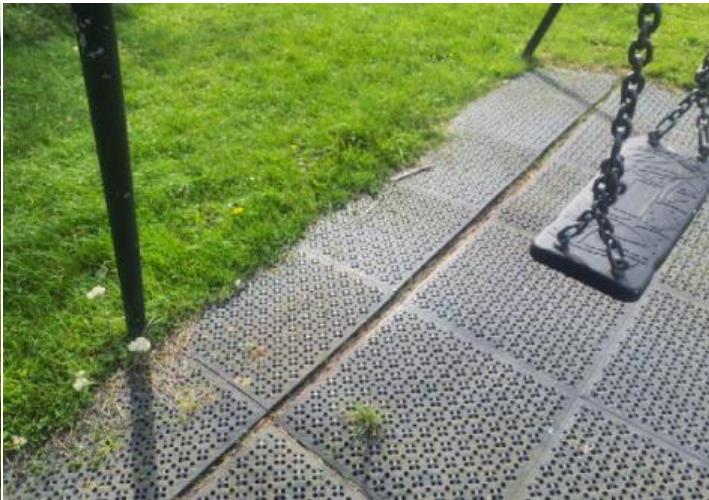
<b>Finding:</b> There are gaps opening in between the tiles	<b>Action:</b> Reinstate the surface

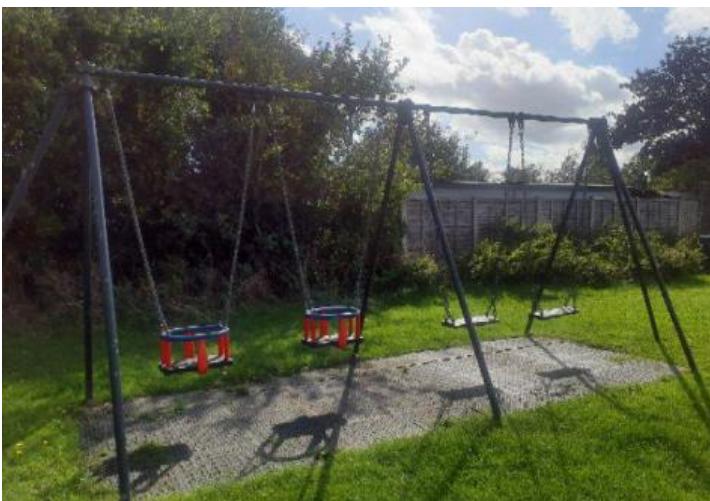
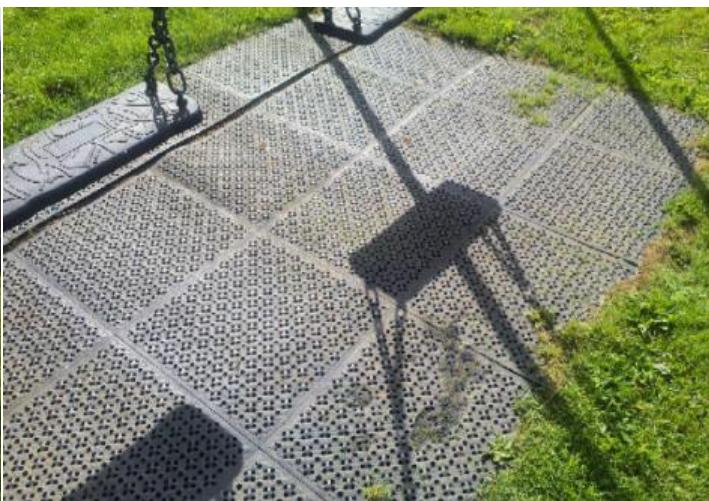
<b>Finding:</b> There is some evidence of fire damage to the surfacing	<b>Action:</b> Monitor for any further deterioration and repair as required
