## Annual Inspection

East Hertfordshire District Council

Tonwell Recreation Ground (Bengeo PC)

Inspected: 15-September-2025 - 15:01 by James Law (RPII Annual Inspector)

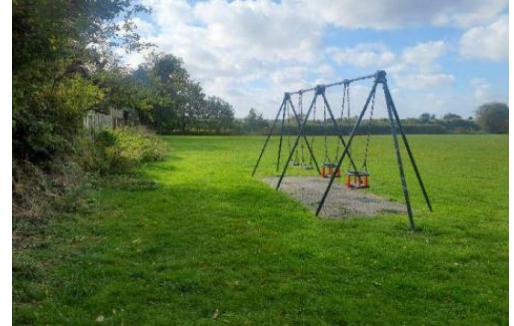
**Finding 1**

There is weed / vegetation growth within the surface - Remove weed / vegetation growth

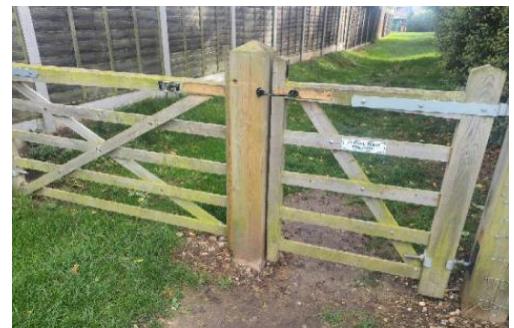
**Finding 1**

The area around the item has eroded and may become slippery - Reinstate eroded area

There are projecting bolt thread(s) present - Remove excess thread length and deburr or provide cap

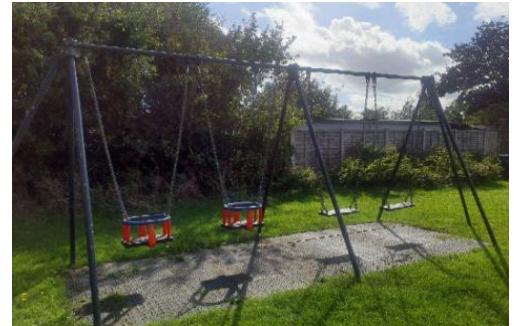
8 - Low Risk	
<b>Item:</b>	2 Bay (2 Flat, 2 Cradle)
<b>Manufacturer:</b>	Wicksteed Playgrounds
<b>Surface Type:</b>	Matta
<b>Item Quantity:</b>	1
<b>Equipment Compliance:</b>	No
<b>Surface Area Compliance:</b>	Yes
<b>Total Findings:</b>	5

<b>Finding 1</b>	<b>Finding 2</b>
The seat/s is / are too close to the frame as defined in BS EN 1176 Part 2 - Monitor - No action given the risk assessment	The seats are too close to each other as defined in BS EN 1176 Part 2; this is a low risk failure and no remedial action is required - Monitor - No action given the risk assessment
<b>Finding 3</b>	<b>Finding 4</b>
The paint is flaking off the metalwork - Rub down and re-paint	There are gaps opening in between the tiles - Reinstate the surface
<b>Finding 5</b>	
There is some evidence of fire damage to the surfacing - Monitor for any further deterioration and repair as required
